Baska Mask Failure: Culprit Resides at the Posterior Commissure

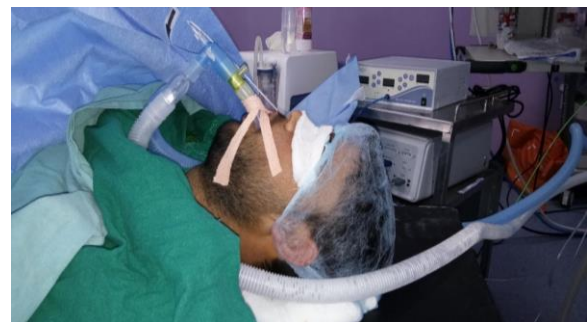
A size 4 Baska Mask lubricated with 2% lignocaine jelly was inserted orally. It was connected to the circle anesthesia breathing system (Figure 1).

Figure 1- Buska Mask of size 4 insitu

Ventilation with self-inflating bag experienced high airway resistance and on auscultation bilaterally equal but decreased breath sounds were heard. Chest rise was also not adequate. The bite block of the Baska mask was inside the mouth. Peak inspiratory pressure reached 28 cmH₂O and EtCO₂ progressively increased to 40 mmHg.

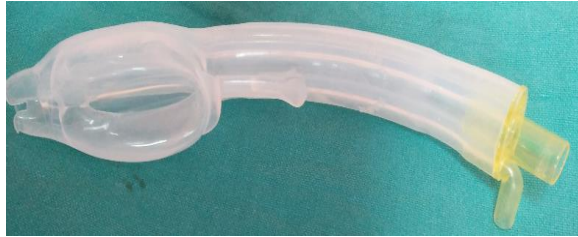
The circuit was disconnected and BM was removed (Figure 2).

Figure 2- Removed Baska Mask of size 4

Bag mask ventilation was done for 3 minutes. Then for the diagnostic purpose, we did laryngoscopy to find out the obstructive cause of upper airway obstruction in BM placement. It was found that there was a swelling undiagnosed at the posterior commissure which would have prevented effective seal in the supraglottic region. The patient was immediately intubated with an 8.5-mm cuffed polyvinyl chloride (PVC) endotracheal tube and was connected to the ventilator. All ventilatory parameters became normal and the surgery was started. The rest of the intraoperative course went uneventful. The patient was extubated successfully at the end of the surgery.
